ENERGY STAR Showcase Building Project

*Demonstrating Profitable Energy Savings
in Retail Establishments*

**Target Store
Fullerton, California**

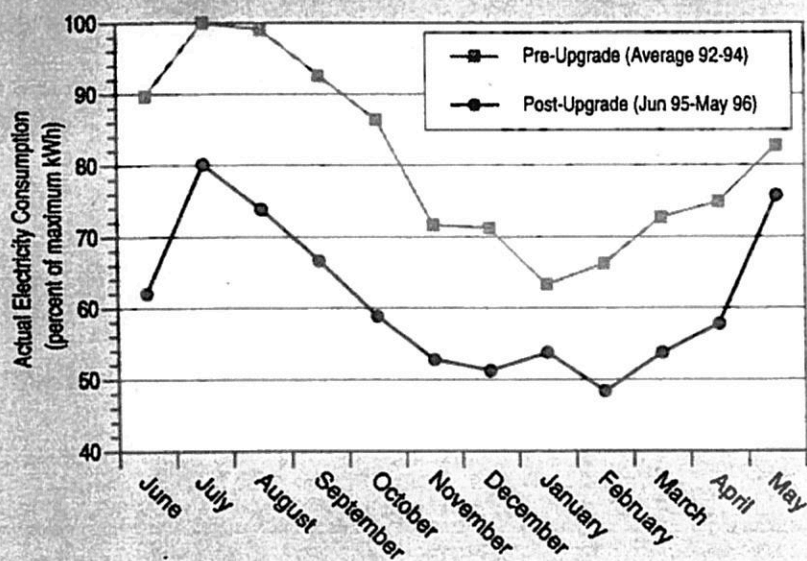
Exhibit 2. Pre- and Post-Upgrade Monthly Electricity Consumption

Electrical energy savings were confirmed by actual electric bills. Pre-upgrade electric use was based on an average of electricity consumed from January 1992 through December 1994. Post-upgrade energy use was analyzed from June 1995 through May 1996. Exhibit 2 displays the difference in energy use expressed as a percent of the maximum monthly kilowatthours consumed.

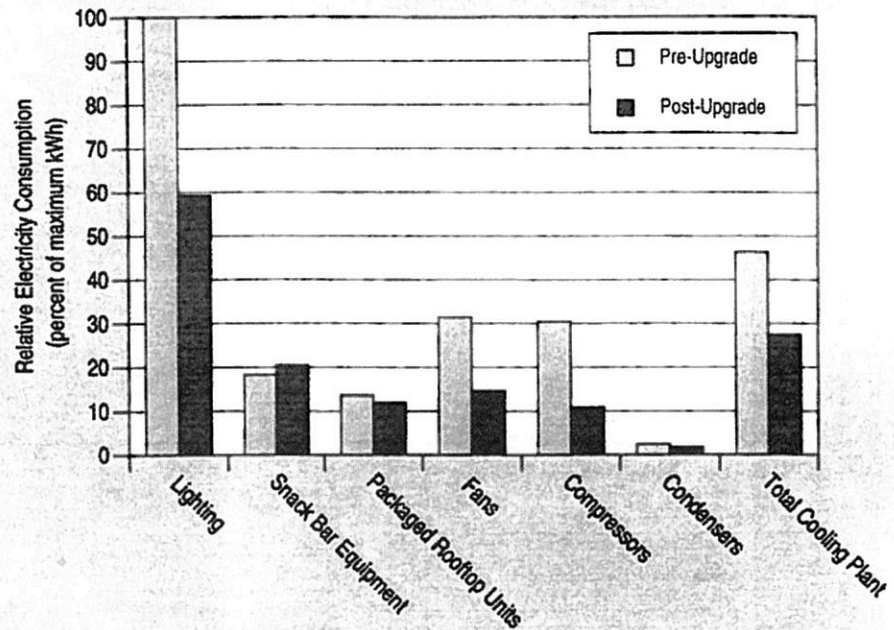
**Exhibit 3. Change in End-Use Electricity Consumption
(Based on Direct Monitoring)**

Through direct monitoring with kilowatt loggers connected at electrical panels, the percentage of energy saved by specific end-uses could also be quantified. Results are displayed in Exhibit 3.

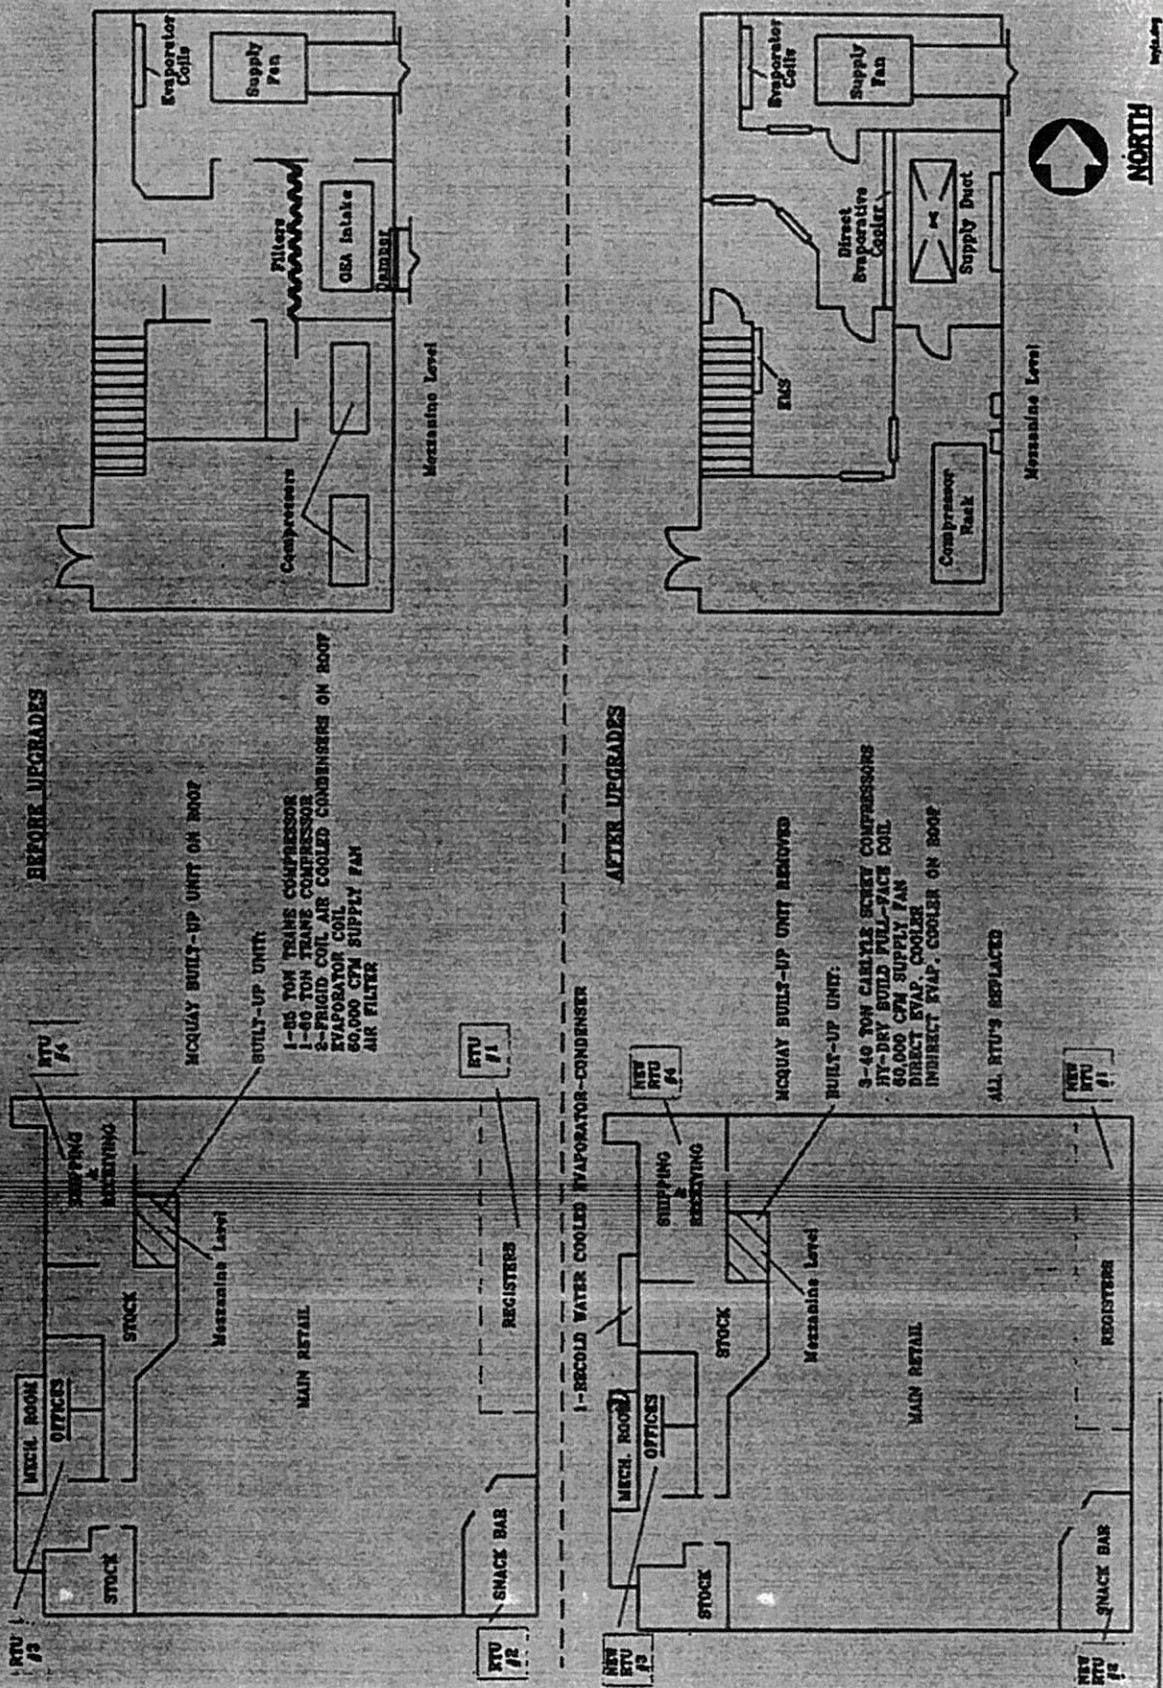
Exhibit 5. Floor Plan of Target Store

Target store 293 is located at 2920 Yorba Linda Boulevard in Fullerton, California. It was built in 1975 as a retail and grocery store prior to its purchase by Target in 1987. The 102,080-square-foot facility has four main areas:

- Retail sales floor (including the checkout area).
- Snack bar.
- Shipping and receiving area.
- Stock rooms.
- Offices.

An open-air garden department is adjacent to the structure. Exhibit 4 shows the layout of the store.

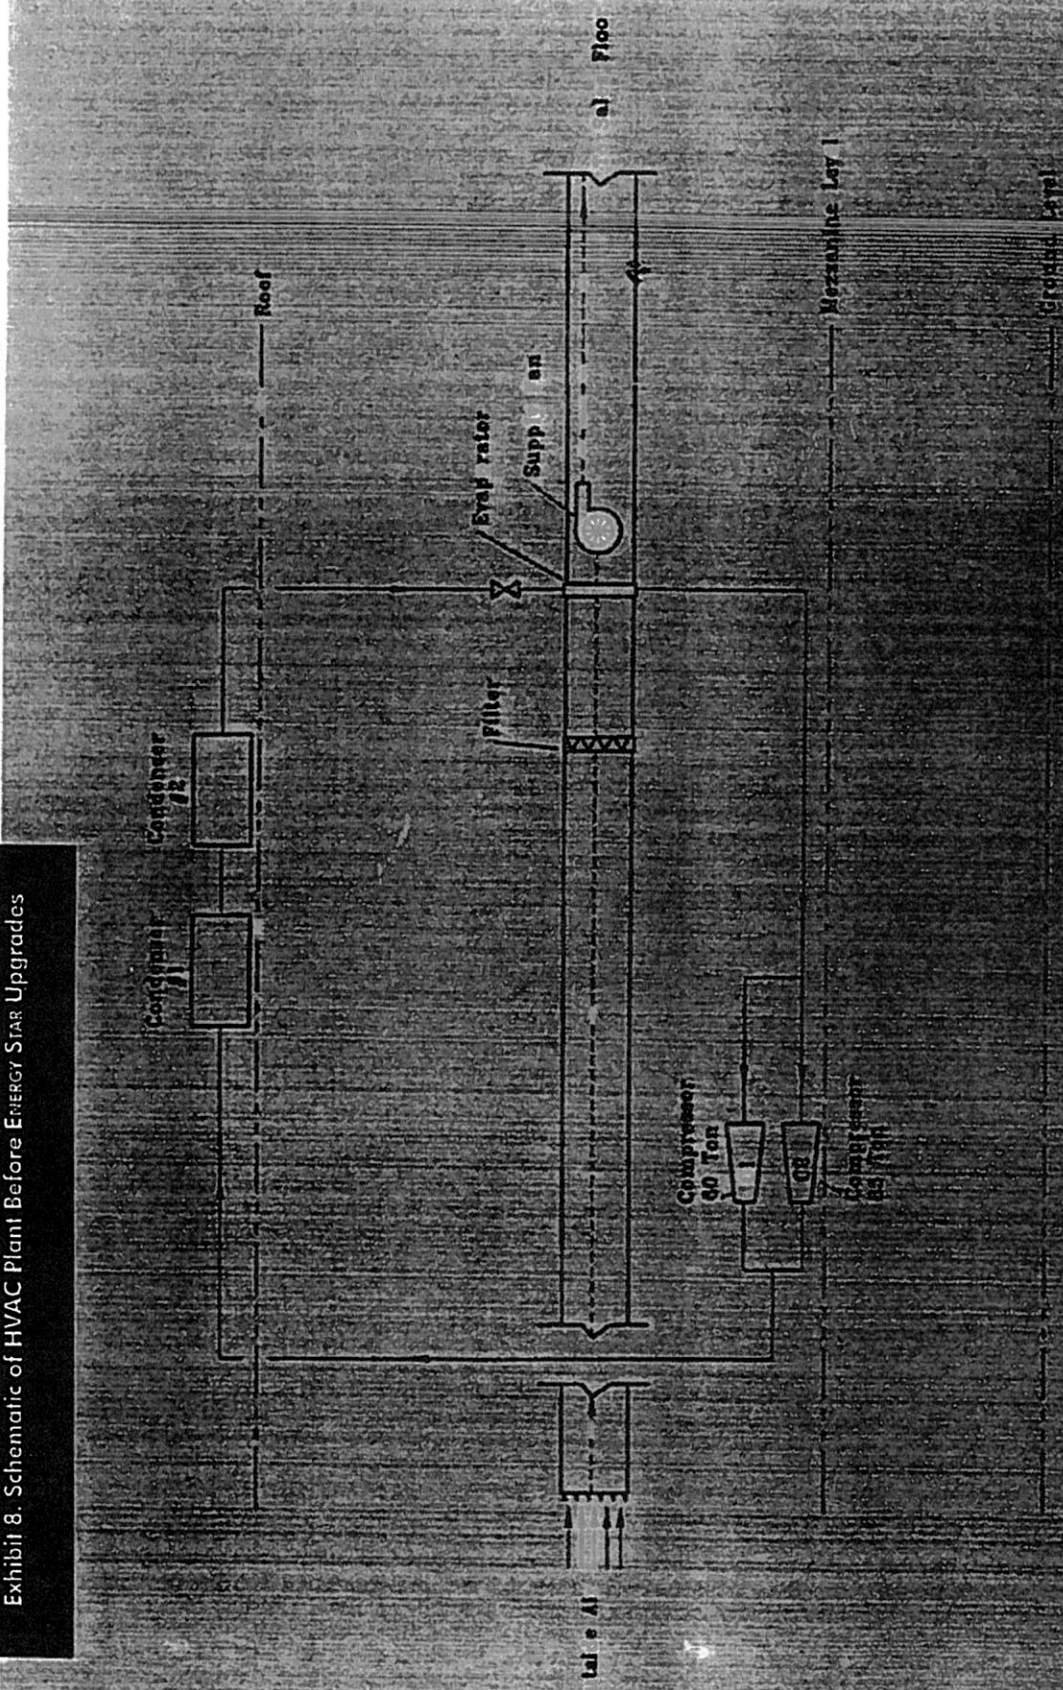
Exhibit 8. Schematic of HVAC Plant Before ENERGY STAR Upgrades

The main retail area was cooled by a direct-expansion system that had two open-drive compressors with capacities of 85 tons and 60 tons. Heat was rejected by two air-cooled condensing units with total capacity of 2,736,800 Btu per hour. The unit that served the area previously used as a grocery store had 30 tons of cooling capacity.

All of the existing HVAC cooling equipment at the Target store needed to be replaced. State-of-the-art systems that would provide significant reductions in energy use were identified to replace the existing equipment. Selection criteria for new units also included use of environmentally friendly refrigerant.

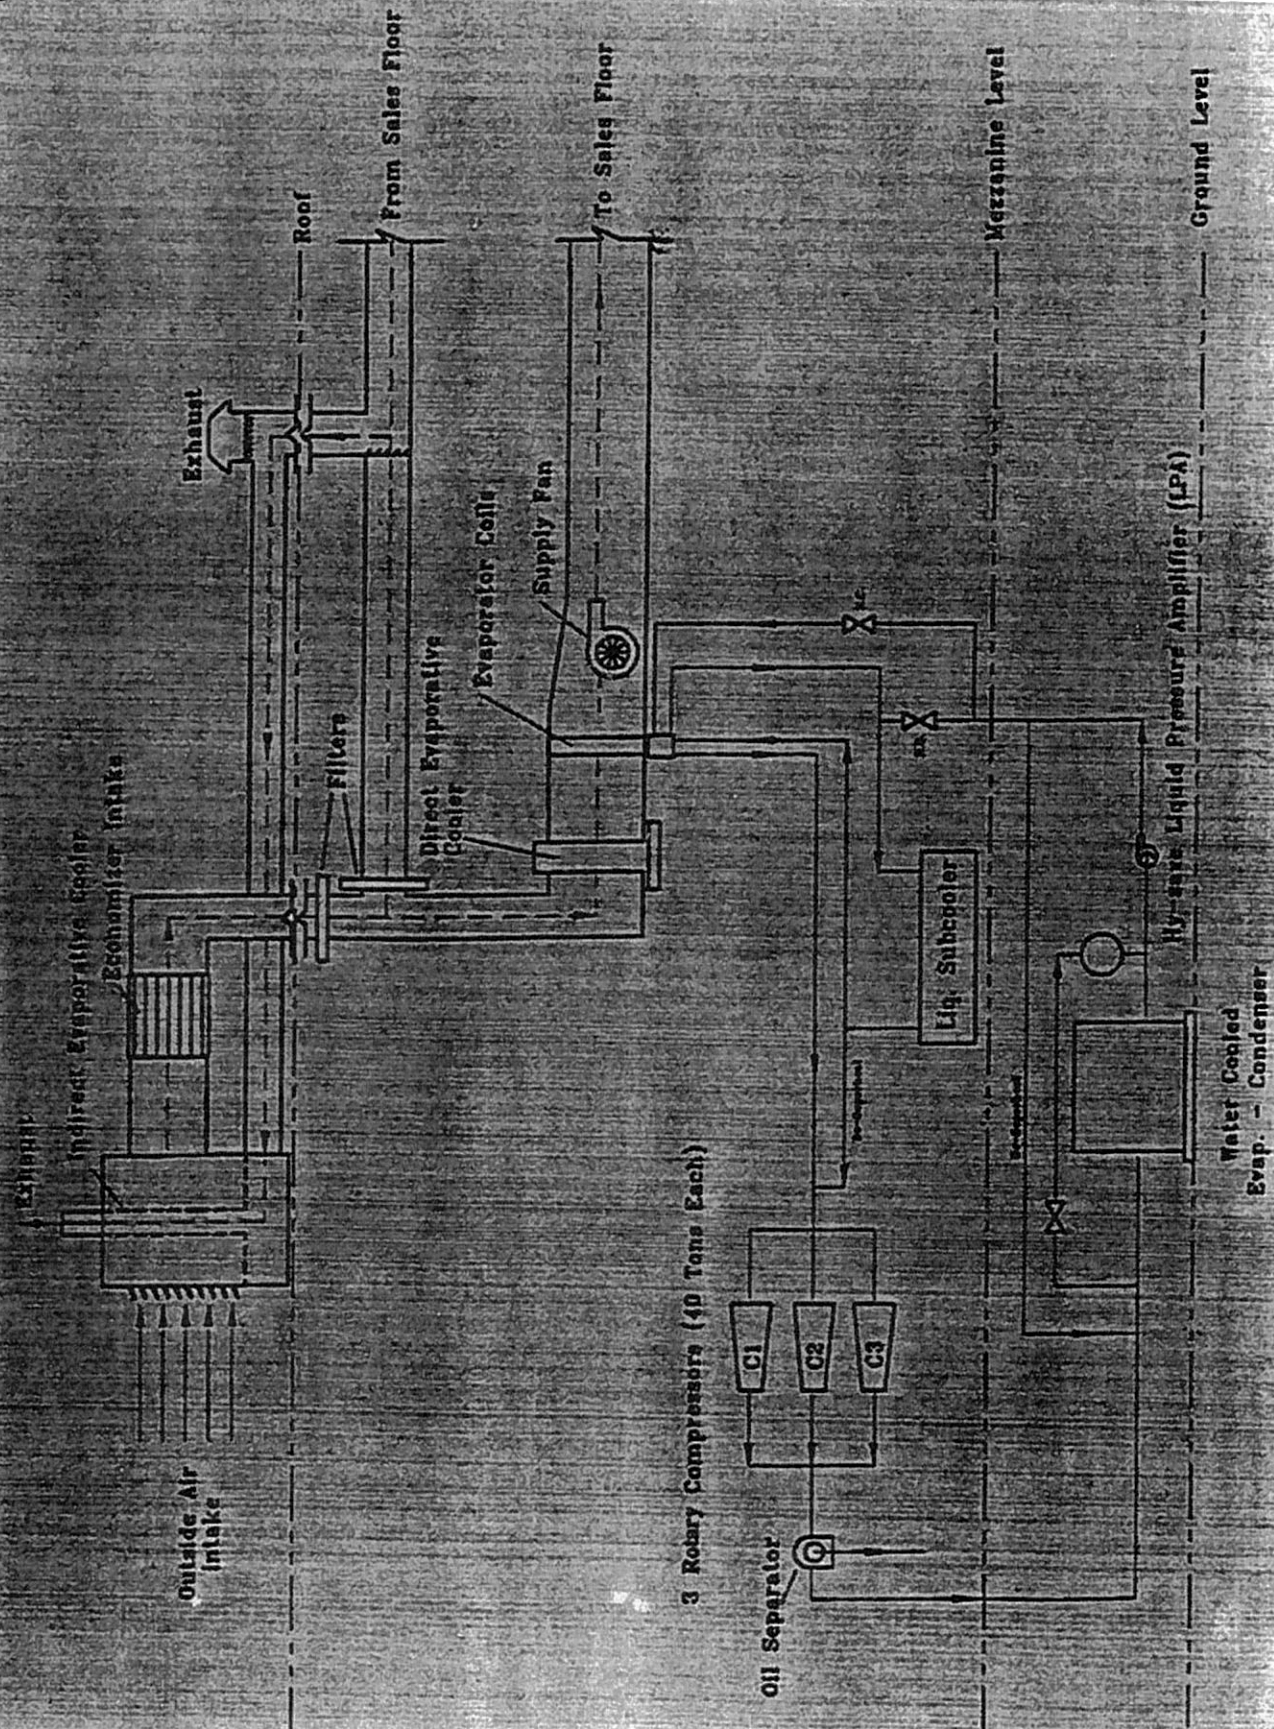
Exhibit 9. Schematic of HVAC Plant After Energy Star Upgrades

The rooftop units were replaced with four new packaged units using a new type of refrigerant, a ternary mixture of HFC-32, HFC-125, and HFC-134a that offers performance and safety characteristics comparable to those of HCFC-22.

- Refrigerant evaporator with a three-circuit, full-face, four-section coil.
- Indirect evaporative cooling unit with a 50-horsepower fan motor, to provide free cooling to incoming air from moisture evaporation by the warm exhaust air.

- Water-cooled evap-condenser (92-degree design) with a linear kinetic cell piped in line with the circulating water pump to control scale buildup.
- Liquid pressure amplifier system consisting of a centrifugal pump placed in the liquid line between the accumulator and expansion valve to improve the efficiency of the refrigeration cycle. Energy is saved by:

Implementation of these upgrades produced an overall 40-percent reduction in HVAC plant energy use at the store.
